**Flood Control Project Maintenance
Levee Inspections**

Fall 2013 Levee Maintenance Deficiency Summary Report

Reclamation District No. 0150 Merrit Island

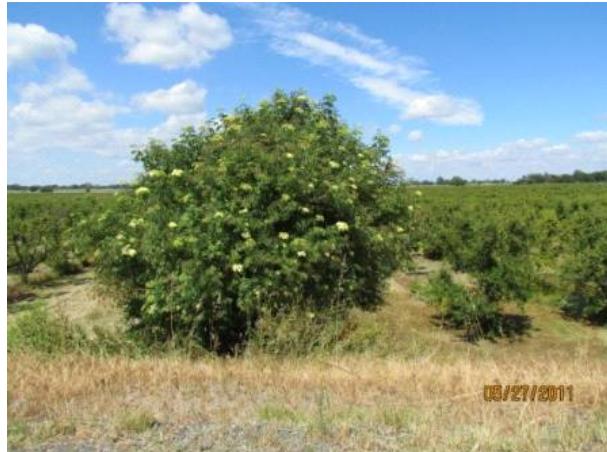
Levee Mile Report Line	4
Start Levee Mile	0.20
End Levee Mile	0.20
Location	Land Side
Category	Earthen Levee
Item	Vegetation
Elderberry bush was found on the landside of the levee. The picture was taken from the crown looking downstream.	
pkazi_f_20131001_569.jpg

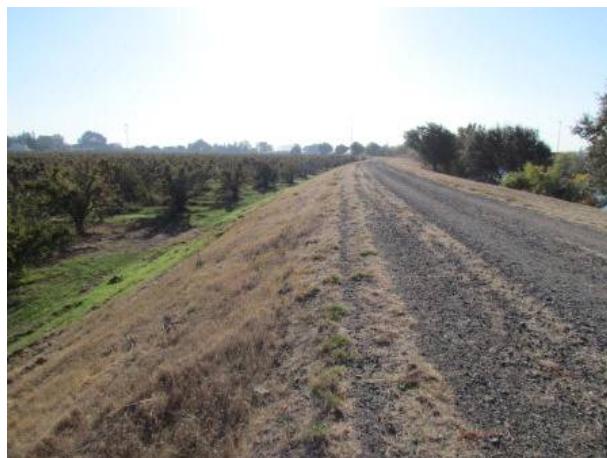
Levee Mile Report Line	5
Start Levee Mile	0.20
End Levee Mile	0.20
Location	Land Side
Category	Earthen Levee
Item	Vegetation
View of the landside slope of the levee looking downstream.	
pkazi_f_20131104_030.JPG

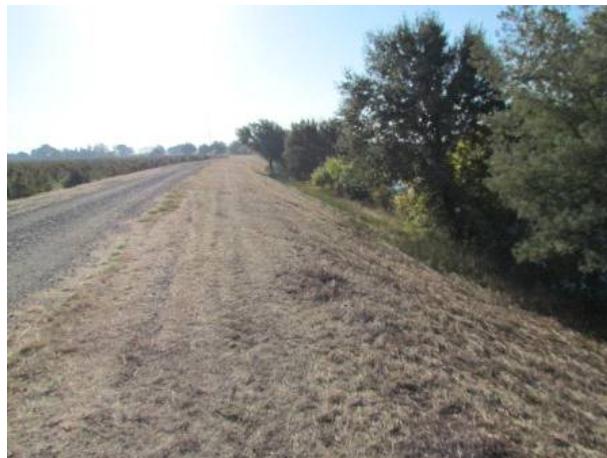
Levee Mile Report Line	6
Start Levee Mile	0.20
End Levee Mile	0.20
Location	Water Side
Category	Earthen Levee
Item	Vegetation
View of the waterside slope of the levee looking downstream.	
pkazi_f_20131104_031.JPG

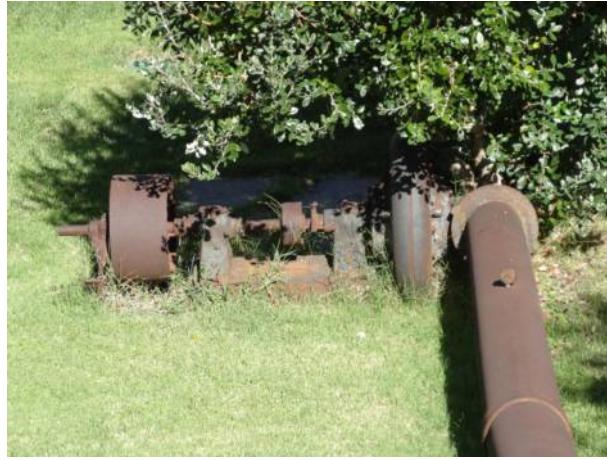
5	0.23	0.23	Supplemental DWR UCIP Field Study		LS M En	Inspector Comments: FS_ID:18564 EP_NO: N/A Repair Type: Non-Urgent Crossing Status: Found UCIP Comments: - Concrete box on landside.. Dense vegetation on waterside. FIELD_STRUCT_DESC: 10-inch steel pipe through the levee, 2.8 feet below the crown. Pump on landside. O&M Manual SAC 112, March 1957. FS Date: 8/27/2013	38.330888 °	38.330888 °	52 -121.573769 ° -121.573769 ° DWR ID: DWR_RD0150_02_f_2013_52	
6	0.24	0.24	Supplemental DWR UCIP Field Study		LS M En	Inspector Comments: FS_ID:18526 EP_NO: N/A Repair Type: Non-Urgent Crossing Status: Found UCIP Comments: - Concrete box on landside.. Dense vegetation on waterside. FIELD_STRUCT_DESC: 10-inch steel pipe through the levee, 2.8 feet below the crown. Pump on landside. O&M Manual SAC 112, March 1957. FS Date: 8/27/2013	38.330874 °	38.330874 °	53 -121.573782 ° -121.573782 ° DWR ID: DWR_RD0150_02_f_2013_53

Levee Mile Report Line	4
Start Levee Mile	0.23
End Levee Mile	0.23
Location	Land Side
Category	Supplemental
Item	DWR UCIP Field Study
LS view: abandoned pipe and pump on landside toe.	
UCIP_12197.jpg

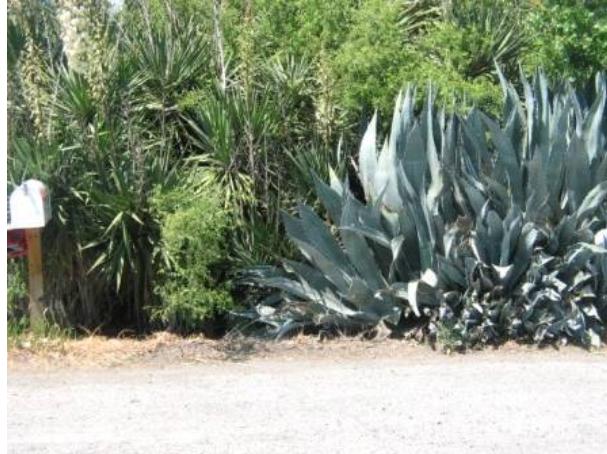
Levee Mile Report Line	8
Start Levee Mile	0.25
End Levee Mile	0.25
Location	Land Side
Category	Earthen Levee
Item	Vegetation
Landscaping on landward slope at LM 0.25 blocking view of levee slope.	
pkazi_f_20131001_571.jpg

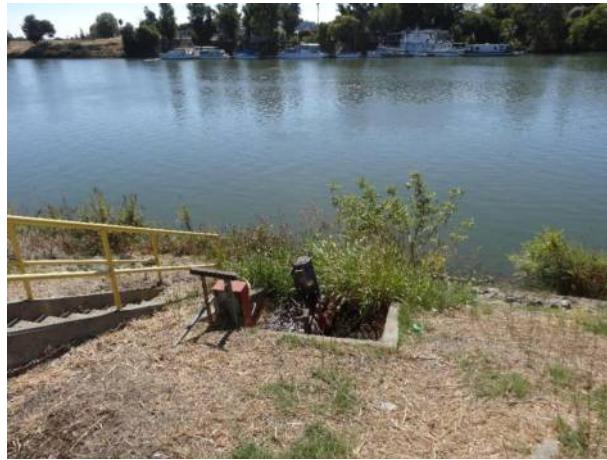
Levee Mile Report Line	11
Start Levee Mile	0.39
End Levee Mile	0.39
Location	Land Side
Category	Supplemental
Item	DWR UCIP Field Study
WS view: walkway/stairs, pump on levee slope.	
UCIP_12201.jpg

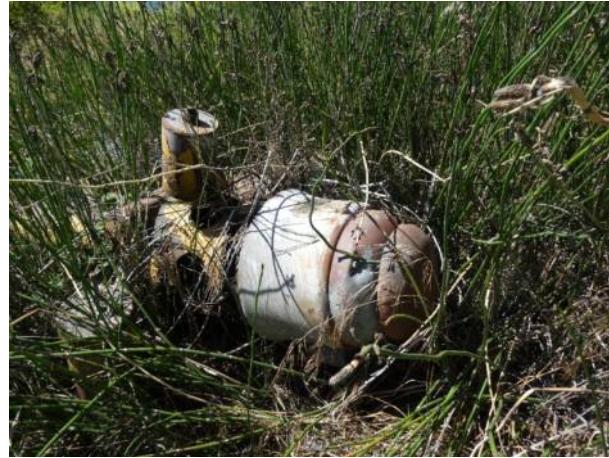
Levee Mile Report Line	17
Start Levee Mile	0.48
End Levee Mile	0.48
Location	Water Side
Category	Supplemental
Item	DWR UCIP Field Study
WS view: abandoned pump on levee slope. Dense vegetation on waterside.	
UCIP_12203.jpg

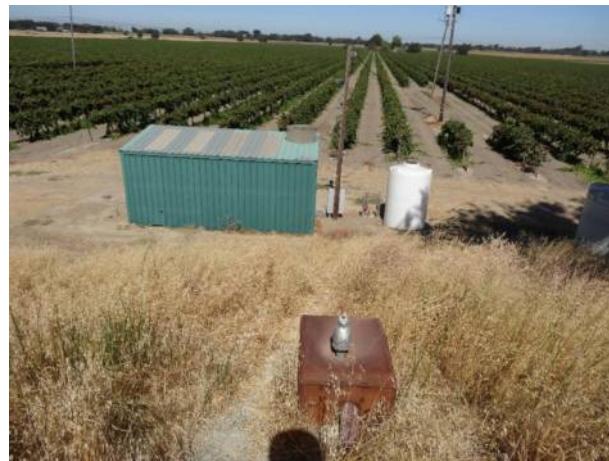
Levee Mile Report Line	19
Start Levee Mile	0.70
End Levee Mile	0.70
Location	Water Side
Category	Supplemental
Item	DWR UCIP Field Study
LS view: 10-inch pipe and air vent on levee slope. Concrete standpipe inside Water filtration plant and service pole on levee toe.	
UCIP_12204.jpg

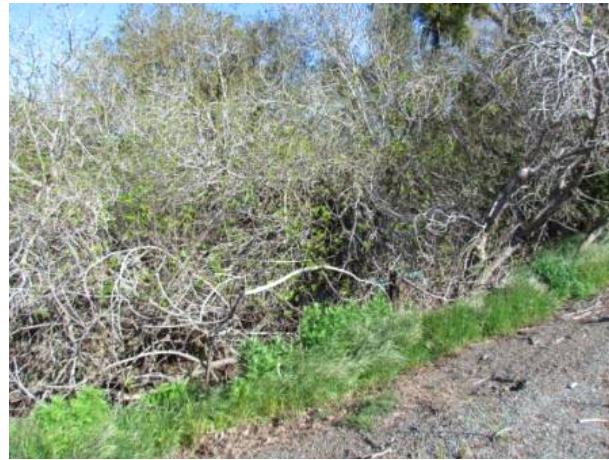
Levee Mile Report Line	21
Start Levee Mile	0.98
End Levee Mile	0.98
Location	Land Side
Category	Earthen Levee
Item	Trim / Thin Trees
Overgrown trees were obstructing the landside slope of the levee looking upstream.	
pkazi_f_20131001_578.JPG

-121.568383 °	-121.568383 °		
21	0.98	0.98	Earthen Levee	Trim / Thin Trees	LS M Ma		T2 : Thin trees to allow visibility of the ground and room to flood fight.	38.339035 °	38.339035 °	12	
								-121.565145 °	-121.565145 °	Y	
										DWR ID: DWR_RD0150_02_s_2012_12	
22	1.00	1.00	Earthen Levee	Encroachments	WS M Ma		TR : Tree or limb Inspector Comments: Tree trunk was found on the waterside toe of the levee.	38.339268 °	38.339268 °	18	
								-121.564839 °	-121.564839 °	Y	
										DWR ID: DWR_RD0150_02_s_2013_18	
23	1.16	1.16	Earthen Levee	Trim / Thin Trees	LS N Ma		T5 : Tree stumps.	38.340864 °	38.340864 °	8	
								-121.562915 °	-121.562915 °	Y	
										DWR ID: DWR_RD0150_02_s_2012_8	
24	1.28	1.28	Earthen Levee	Vegetation	LS M En		V6 : Landscaping	38.342229 °	38.342229 °	92	
								-121.561694 °	-121.561694 °		
										DWR ID: DWR_RD0150_02_s_2012_92	
25	1.34	1.37	Earthen Levee	Vegetation	LS M En		V6 : Landscaping	38.342969 °	38.343252 °	91

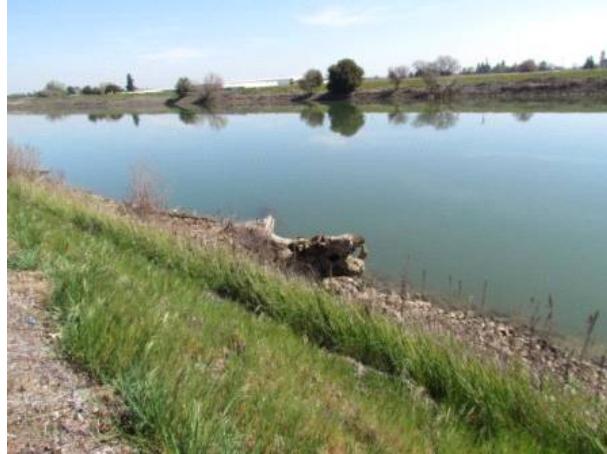
Levee Mile Report Line	22
Start Levee Mile	1.00
End Levee Mile	1.00
Location	Water Side
Category	Earthen Levee
Item	Encroachments
A tree trunk was found on the waterside toe of the levee looking downstream during spring 2013 inspection.	pkazi_f_20131001_583.JPG

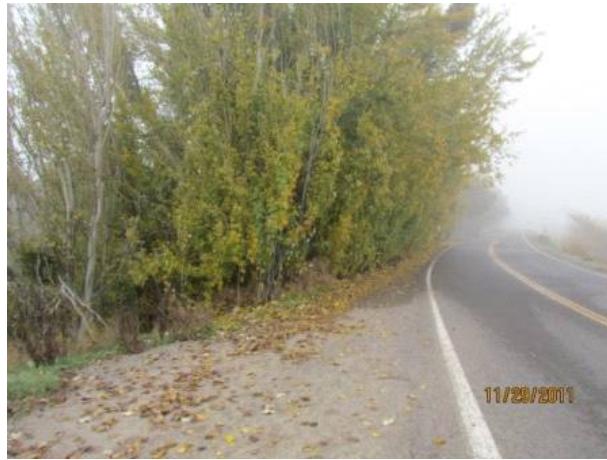
Levee Mile Report Line	25
Start Levee Mile	1.34
End Levee Mile	1.37
Location	Land Side
Category	Earthen Levee
Item	Vegetation
Landscaping was found landside of the levee looking upstream.	pkazi_f_20131001_614.jpg

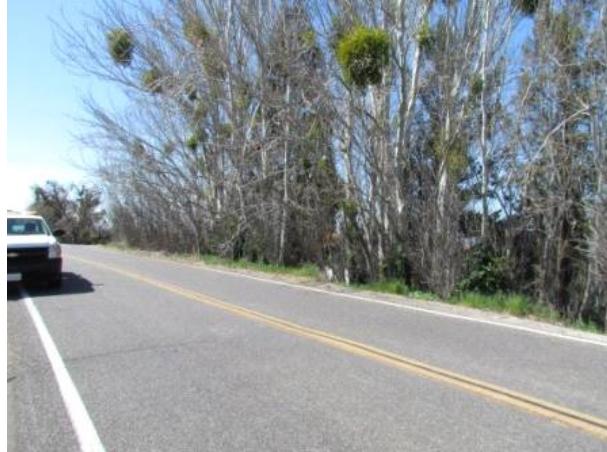
Levee Mile Report Line	25
Start Levee Mile	1.34
End Levee Mile	1.37
Location	Land Side
Category	Earthen Levee
Item	Vegetation
<p>Landscaping was obstructing the view of the landside slope of the levee looking downstream. This picture was taken during spring 2013 inspection.</p> <p>pkazi_f_20131001_615.JPG</p>

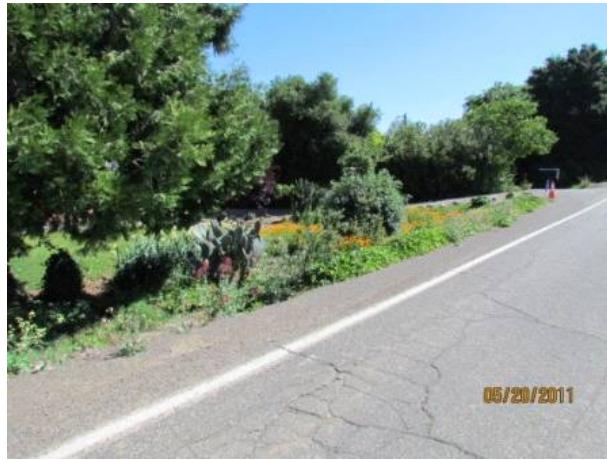
Levee Mile Report Line	28
Start Levee Mile	2.31
End Levee Mile	2.33
Location	Land Side
Category	Earthen Levee
Item	Vegetation
<p>Landscaping was found on the landside of the levee. The picture was taken from the crown looking upstream.</p> <p>pkazi_f_20131001_613.JPG</p>

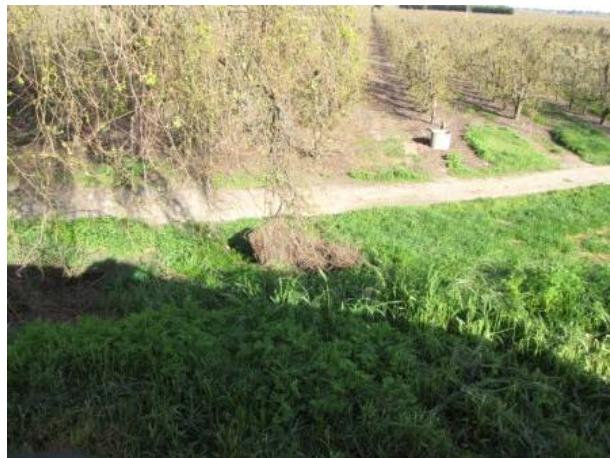
Levee Mile Report Line	30
Start Levee Mile	2.80
End Levee Mile	2.80
Location	Land Side
Category	Earthen Levee
Item	Trim / Thin Trees
View of a tree stump on the landward slope.	
pkazi_f_20131001_580.jpg

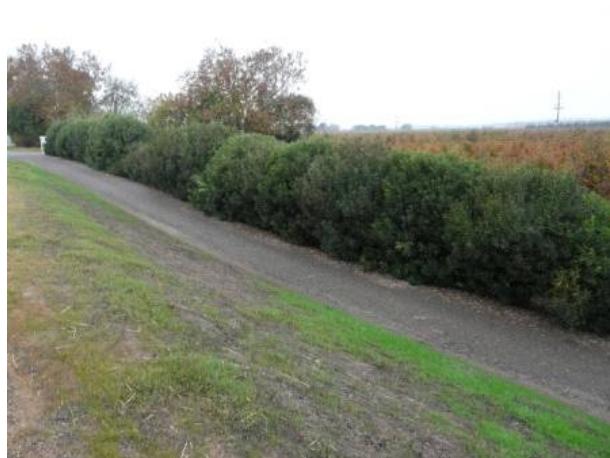
Levee Mile Report Line	32
Start Levee Mile	3.02
End Levee Mile	3.06
Location	Land Side
Category	Earthen Levee
Item	Vegetation
Landscaping providing a screen for a residence on landside of levee from LM 3.02 to LM 3.06	
pkazi_f_20131001_612.JPG

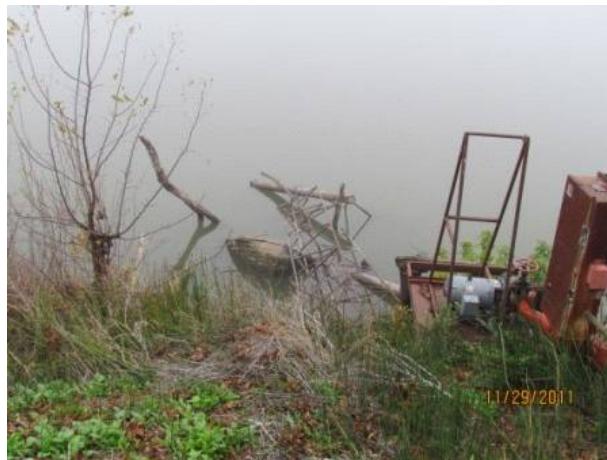
Levee Mile Report Line	33
Start Levee Mile	3.29
End Levee Mile	3.29
Location	Water Side
Category	Earthen Levee
Item	Erosion / Bank Caving
View of the erosion site, and broken pump support along with a boat on the waterside of the levee. The picture was taken from the crown looking towards the toe of the levee during fall 2011 inspection.	
pkazi_f_20131001_621.jpg

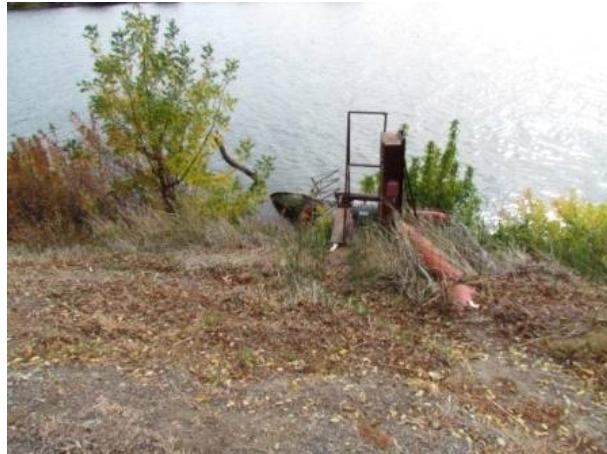
Levee Mile Report Line	33
Start Levee Mile	3.29
End Levee Mile	3.29
Location	Water Side
Category	Earthen Levee
Item	Erosion / Bank Caving
View of erosion and damaged pipe and abandoned boat on the waterside of the levee looking upstream. This picture was taken during fall 2012 inspection.	
pkazi_f_20131001_622.jpg

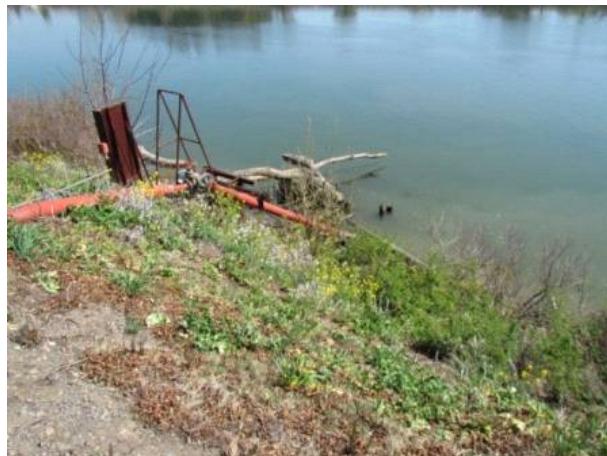
Levee Mile Report Line	33
Start Levee Mile	3.29
End Levee Mile	3.29
Location	Water Side
Category	Earthen Levee
Item	Erosion / Bank Caving
View of the erosion on the waterside slope of the levee looking upstream during spring 2013 inspection.	
pkazi_f_20131001_623.JPG

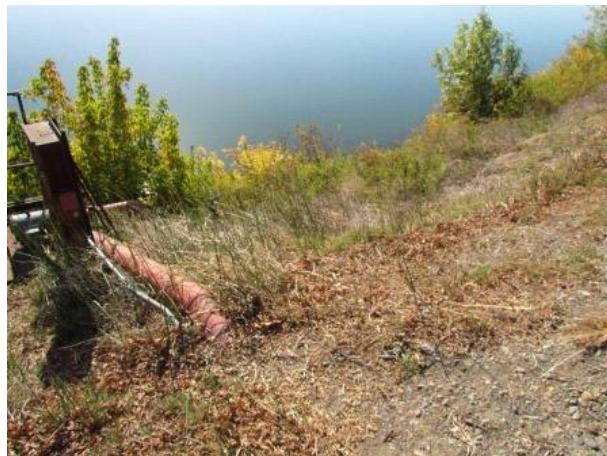
Levee Mile Report Line	33
Start Levee Mile	3.29
End Levee Mile	3.29
Location	Water Side
Category	Earthen Levee
Item	Erosion / Bank Caving
View of the erosion on the waterside slope of the levee near the pipe looking downstream. This picture was taken during the fall 2013 inspection.	
pkazi_f_20131104_032.JPG

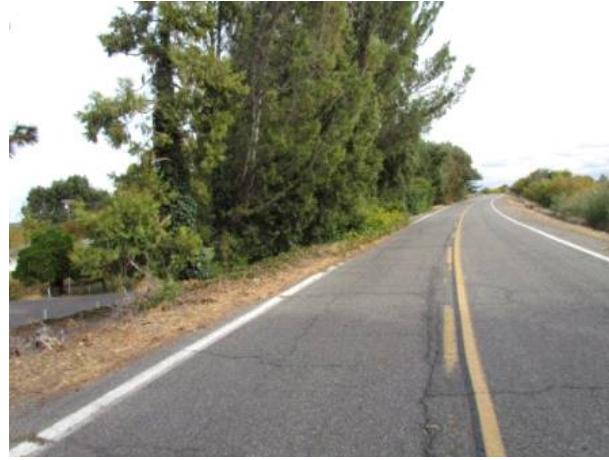
Levee Mile Report Line	36
Start Levee Mile	3.60
End Levee Mile	3.73
Location	Land Side
Category	Earthen Levee
Item	Vegetation
Landscaping was blocking the visibility on the landside of the levee looking upstream.	
pkazi_f_20131001_611.jpg

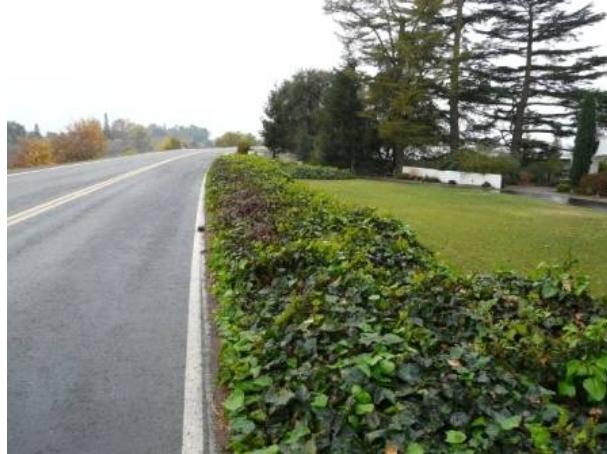
Levee Mile Report Line	38
Start Levee Mile	3.90
End Levee Mile	3.93
Location	Land Side
Category	Earthen Levee
Item	Vegetation
Landscaping in front of a residence on landside of levee from LM 3.90 to LM 3.93. The levee in this location is greater than 100' wide.	
pkazi_f_20131001_610.JPG

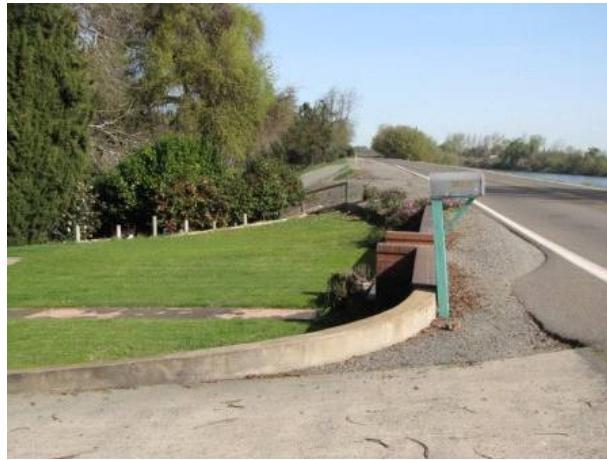
Levee Mile Report Line	40
Start Levee Mile	4.15
End Levee Mile	4.16
Location	Land Side
Category	Earthen Levee
Item	Encroachments
View of a retaining wall on the landward slope looking upstream.	
pkazi_f_20131001_585.jpg

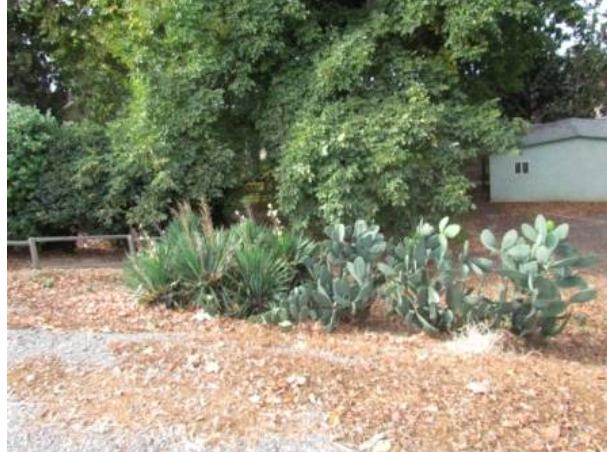
Levee Mile Report Line	41
Start Levee Mile	4.17
End Levee Mile	4.17
Location	Land Side
Category	Earthen Levee
Item	Vegetation
View of cacti on the landside of the levee looking from the crown.	
pkazi_f_20131001_618.jpg

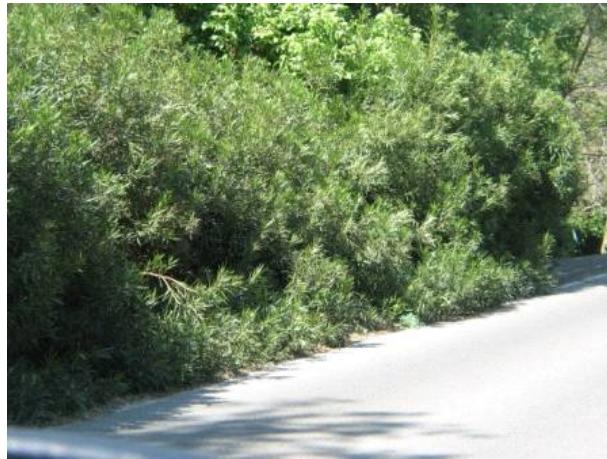
Levee Mile Report Line	42
Start Levee Mile	4.33
End Levee Mile	4.35
Location	Land Side
Category	Earthen Levee
Item	Vegetation
Landscaping (Oleander) on landward slope from 4.33 to 4.35	
pkazi_f_20131001_587.jpg

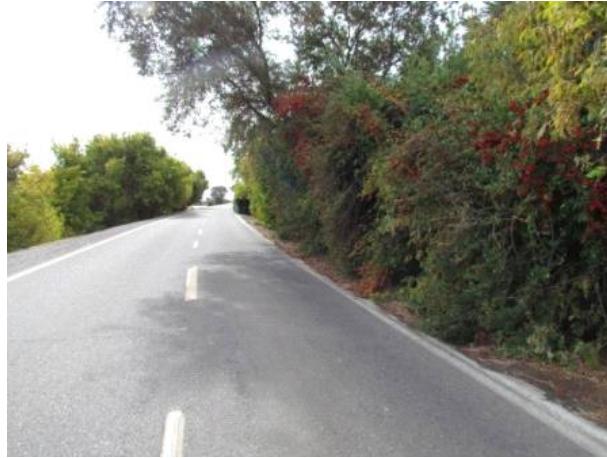
Levee Mile Report Line	43
Start Levee Mile	4.37
End Levee Mile	4.41
Location	Land Side
Category	Earthen Levee
Item	Vegetation
Trees were obstructing the views on the landside slope of the levee looking downstream.	
pkazi_f_20131001_609.jpg

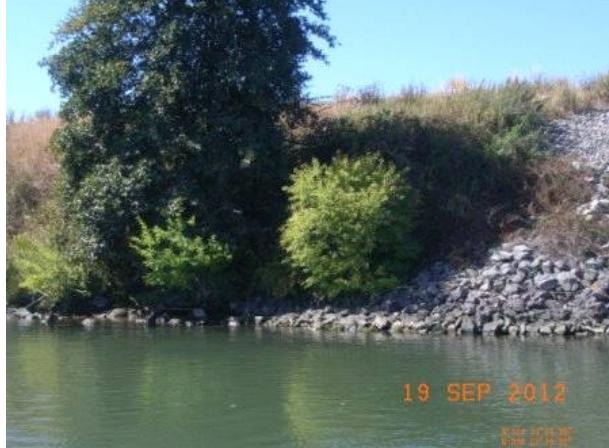
USACE 2012 Photo #1

Levee Mile Report Line	44
Start Levee Mile	4.50
End Levee Mile	4.50
Location	Water Side
Category	Supplemental
Item	USACE Erosion Survey

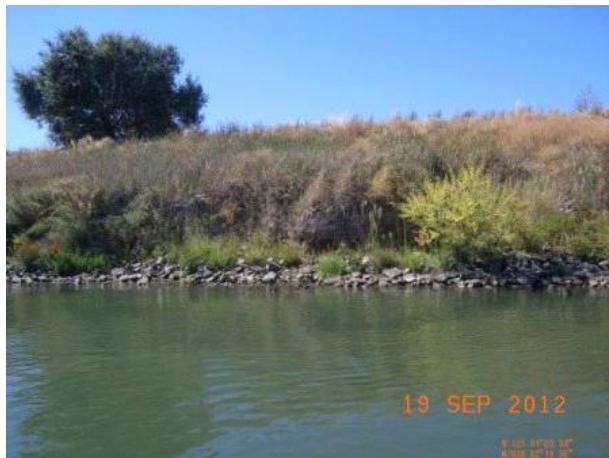
USACE 2012 Photo #2

Levee Mile Report Line	44
Start Levee Mile	4.50
End Levee Mile	4.50
Location	Water Side
Category	Supplemental
Item	USACE Erosion Survey

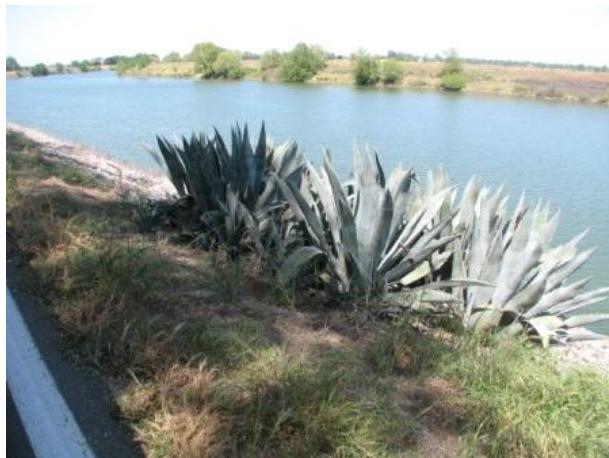
Century plant on waterward slope at LM 4.76

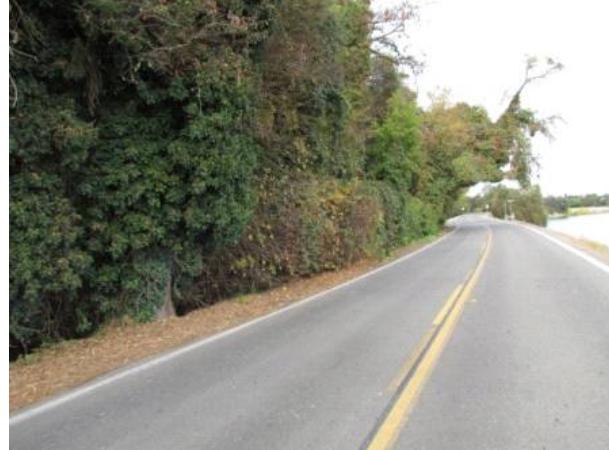
Levee Mile Report Line	46
Start Levee Mile	4.78
End Levee Mile	4.79
Location	Land Side
Category	Earthen Levee
Item	Vegetation
Trees were obstructing the view of the landside slope of the levee looking upstream.	
pkazi_f_20131001_608.jpg

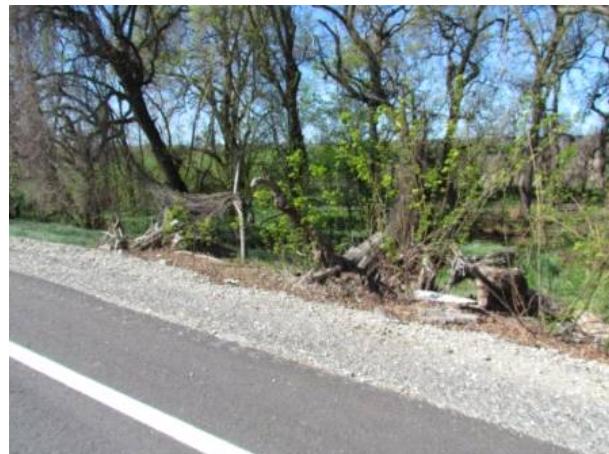
Levee Mile Report Line	48
Start Levee Mile	4.98
End Levee Mile	4.98
Location	Land Side
Category	Earthen Levee
Item	Trim / Thin Trees
Tree stumps were found on the landside of the levee looking from the crown.	
pkazi_f_20131001_597.jpg

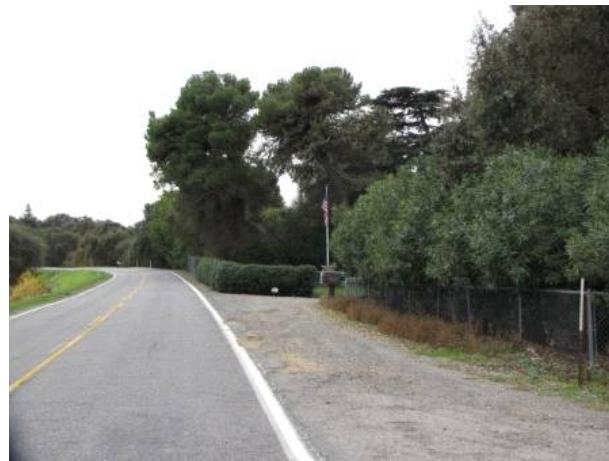
Levee Mile Report Line	51
Start Levee Mile	5.17
End Levee Mile	5.22
Location	Land Side
Category	Earthen Levee
Item	Vegetation
View of landscaping along the landward shoulder and slope looking downstream.	
pkazi_f_20131001_607.jpg

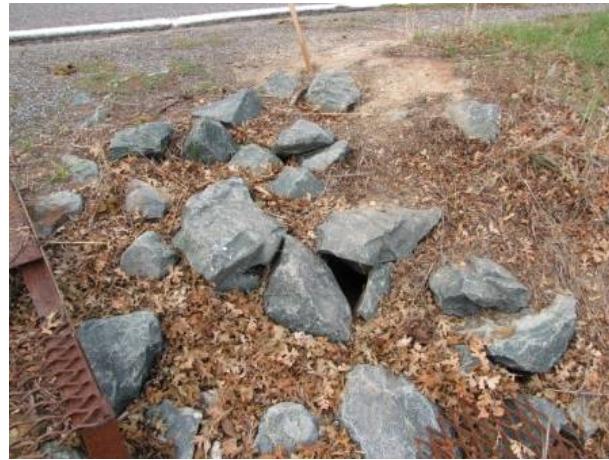
Levee Mile Report Line	52
Start Levee Mile	5.33
End Levee Mile	5.33
Location	Water Side
Category	Earthen Levee
Item	Slope Stability
View of rock placed on a pipe penetration on the waterward slope. Cavities can be seen under the rocks.	
pkazi_f_20131001_627.jpg

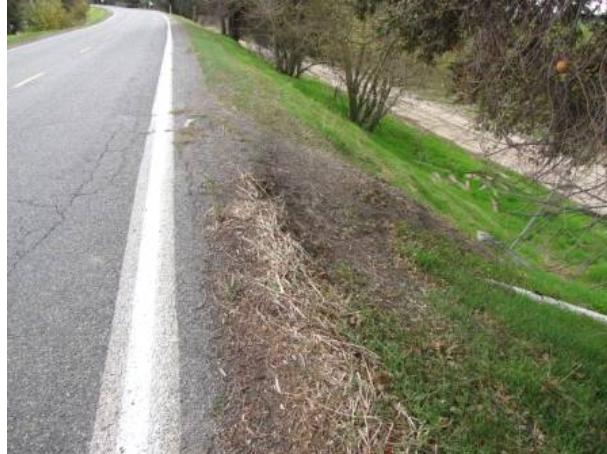
Levee Mile Report Line	53
Start Levee Mile	5.33
End Levee Mile	5.33
Location	Land Side
Category	Earthen Levee
Item	Slope Stability
View of a minor depression along the landward slope of the levee over a pipe penetration looking downstream.	
pkazi_f_20131001_626.jpg

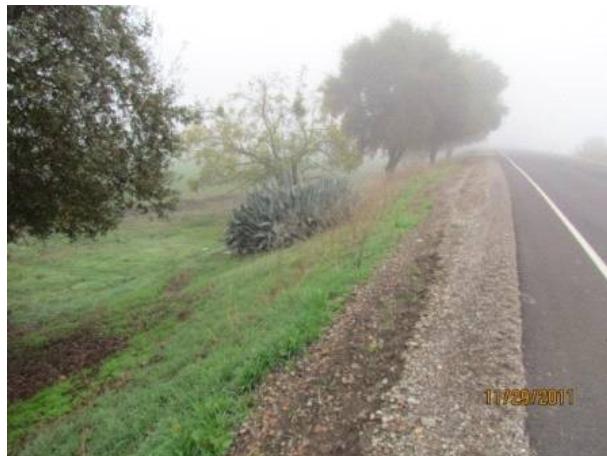
Levee Mile Report Line	56
Start Levee Mile	6.41
End Levee Mile	6.41
Location	Land Side
Category	Earthen Levee
Item	Vegetation
Century plant was found on the landside of the levee looking upstream.	
pkazi_f_20131001_589.jpg

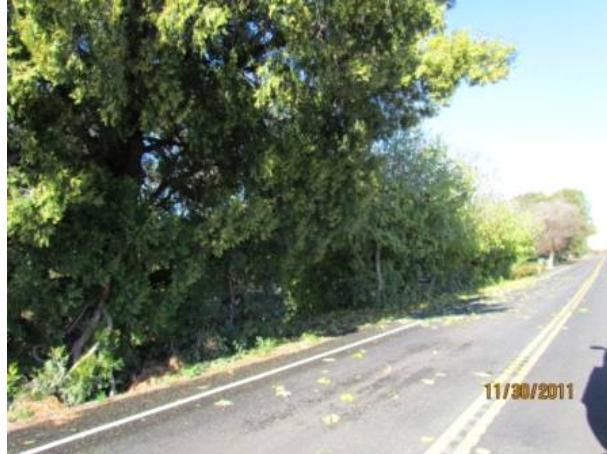
Levee Mile Report Line	58
Start Levee Mile	6.46
End Levee Mile	6.46
Location	Land Side
Category	Earthen Levee
Item	Vegetation
Trees need to be trimmed on the landside of the levee looking upstream.	
pkazi_f_20131001_592.jpg

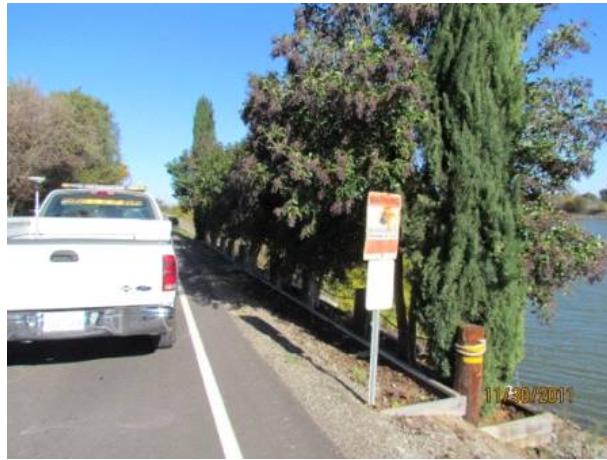
Levee Mile Report Line	60
Start Levee Mile	6.53
End Levee Mile	6.53
Location	Water Side
Category	Earthen Levee
Item	Vegetation
Landscaping was found on the waterside of the levee looking upstream.	
pkazi_f_20131001_594.jpg

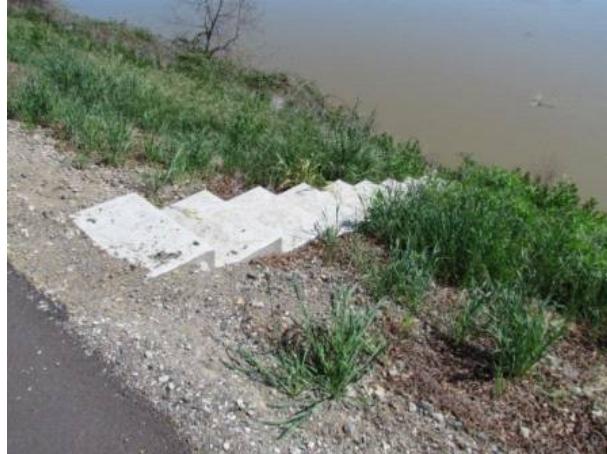
Levee Mile Report Line	61
Start Levee Mile	6.59
End Levee Mile	6.59
Location	Water Side
Category	Earthen Levee
Item	Encroachments
A stairway was found on the waterside slope of the levee looking upstream.	
<i>pkazi_f_20131001_598.jpg</i>

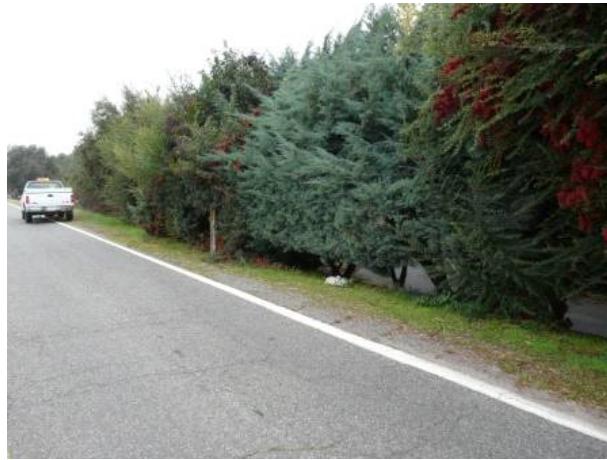
Levee Mile Report Line	63
Start Levee Mile	6.67
End Levee Mile	6.72
Location	Land Side
Category	Earthen Levee
Item	Vegetation
Landscaping providing a screen for a residence on landside of levee from LM 6.68 to LM 6.72	
<i>pkazi_f_20131001_605.JPG</i>

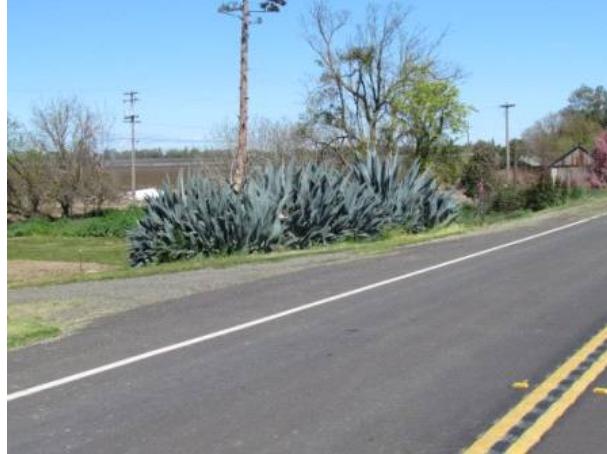
Levee Mile Report Line	64
Start Levee Mile	6.75
End Levee Mile	6.75
Location	Land Side
Category	Earthen Levee
Item	Vegetation
Century plants were found on the landside of the levee looking upstream.	
pkazi_f_20131001_599.jpg

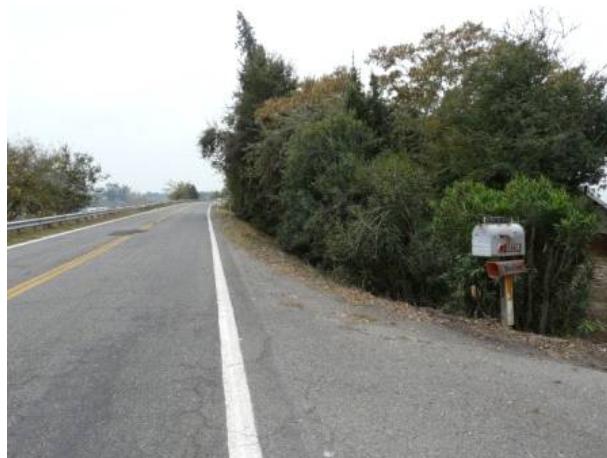
Levee Mile Report Line	66
Start Levee Mile	6.93
End Levee Mile	7.05
Location	Land Side
Category	Earthen Levee
Item	Vegetation
Landscaping providing a screen for a residence on the landside of levee from LM 6.93 to LM 7.05	
pkazi_f_20131001_604.JPG

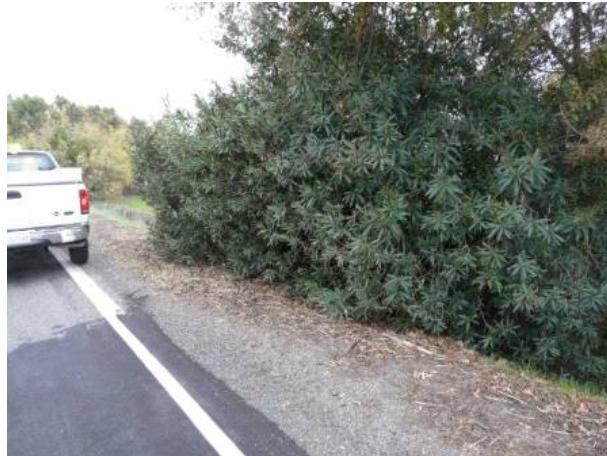
Levee Mile Report Line	67
Start Levee Mile	7.12
End Levee Mile	7.12
Location	Land Side
Category	Earthen Levee
Item	Vegetation
Landscaping providing a screen for a residence on landside of levee at LM 7.12	
pkazi_f_20131001_603.JPG

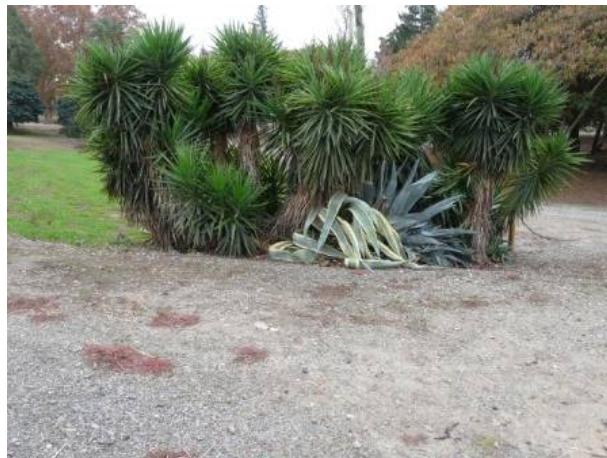
Levee Mile Report Line	72
Start Levee Mile	7.92
End Levee Mile	7.92
Location	Land Side
Category	Earthen Levee
Item	Vegetation
Landscaping on landside of levee at LM 7.92	
pkazi_f_20131001_602.JPG

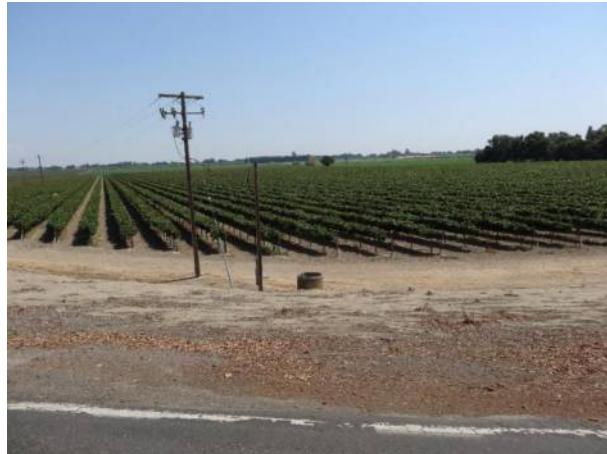
Levee Mile Report Line	1
Start Levee Mile	0.00
End Levee Mile	0.00
Location	Land Side
Category	Supplemental
Item	DWR UCIP Field Study
LS view: power pole and concrete standpipe on levee toe.	
UCIP_11172.jpg

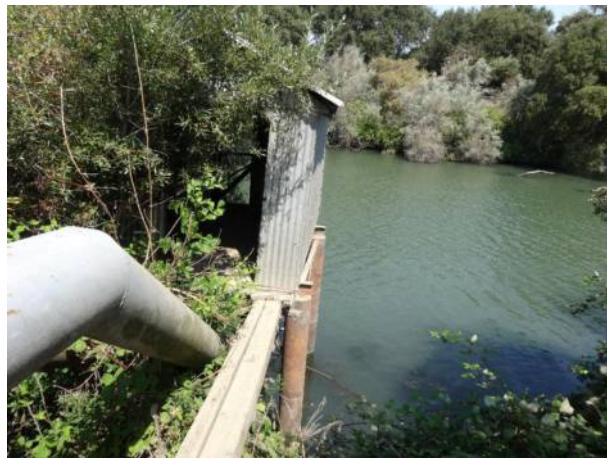
Levee Mile Report Line	3
Start Levee Mile	0.00
End Levee Mile	0.00
Location	Land Side
Category	Supplemental
Item	DWR UCIP Field Study
WS view: pipe, wooden walkway and pump house in channel.	
UCIP_11120.jpg

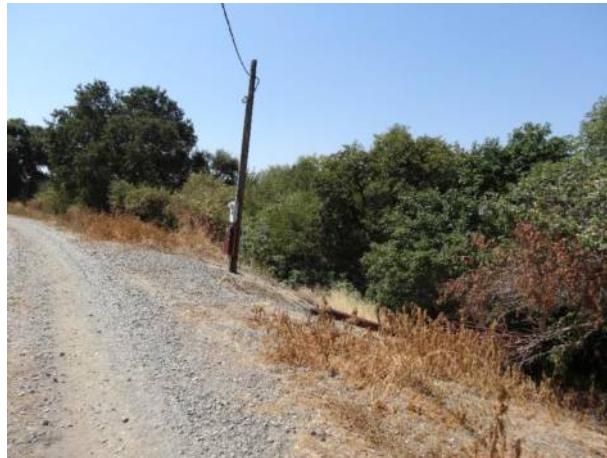
Levee Mile Report Line	4
Start Levee Mile	0.00
End Levee Mile	0.00
Location	Land Side
Category	Supplemental
Item	DWR UCIP Field Study
WS view: exposed pipe and power pole on levee slope.	
UCIP_11156.jpg

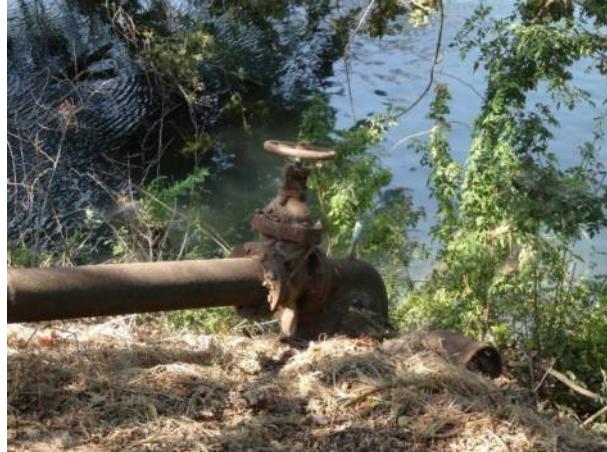
UCIP_11098.jpg

WS view: pipe and pump on levee slope.

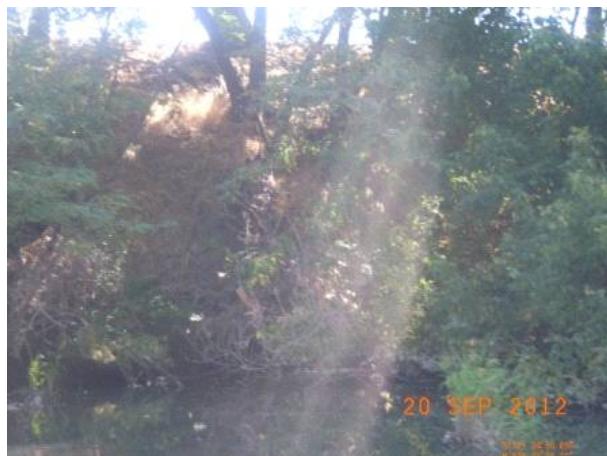
USACE 2012 Photo #1

DWR ID: DWR_RD0150_03_f_2013_99		
7	0.00	9.40	Supplemental USACE Erosion Survey	USACE Erosion Survey	WS Ob	M	Inspector Comments: 1997 - Most of lower Elk Slough contains high near vertical banks, with erosion into the levee slope. Channel almost appears incised. 2002 - Sites where the levee slope is near vertical and severely eroding. It could fail catastrophically. 2004 - Looks bad in terms of vertical slopes and fallen trees. 2005 - Banks are still over steepened in most places and potentially susceptible to geotechnical failures. 2006 - Both banks are still over steepened in most places and potentially susceptible to geotechnical failures. 2010 - The entire reach is in poor condition, with severely eroding near vertical slopes, needs a regional repair. 2011 - Channel banks are still oversteepened with erosion continuing. 2012: No observed change. [2012 Site ID: ELK_0-2_L]	38.413893 °	38.332735 °	2	-121.522896 °	-121.583625 °	Y

Levee Mile Report Line	7
Start Levee Mile	0.00
End Levee Mile	9.40
Location	Water Side
Category	Supplemental
Item	USACE Erosion Survey

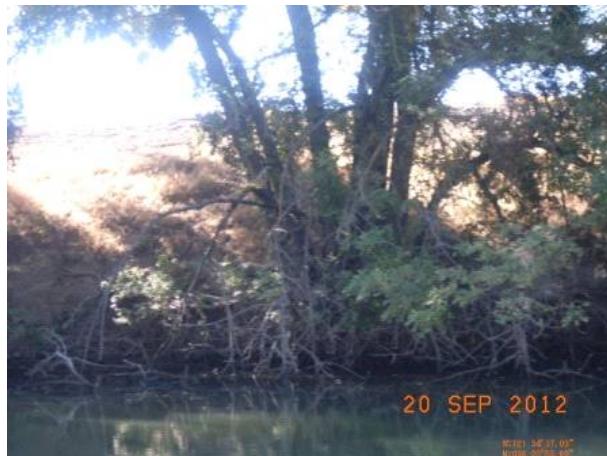
USACE 2012 Photo #2

Levee Mile Report Line	7
Start Levee Mile	0.00
End Levee Mile	9.40
Location	Water Side
Category	Supplemental
Item	USACE Erosion Survey

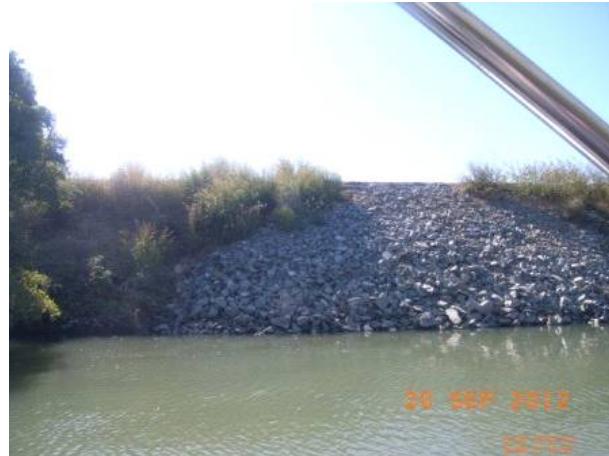
Levee Mile Report Line	7
Start Levee Mile	0.00
End Levee Mile	9.40
Location	Water Side
Category	Supplemental
Item	USACE Erosion Survey
USACE 2012 Photo #3	
USACE2013_ELK_0-2_L_3.jpg

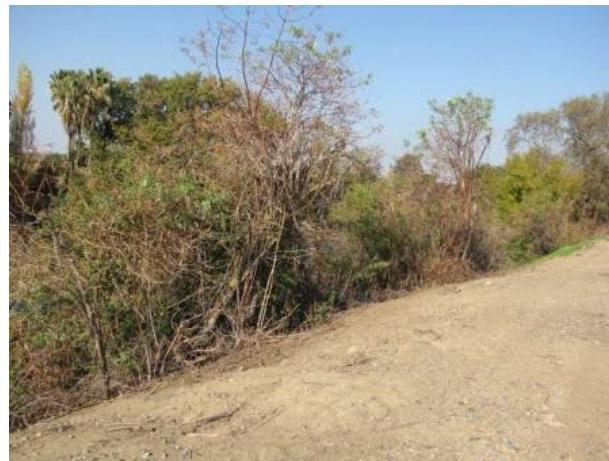
Levee Mile Report Line	8
Start Levee Mile	0.11
End Levee Mile	0.11
Location	Water Side
Category	Earthen Levee
Item	Vegetation
View of elderberry bush within 20 feet of shoulder blocking visibility and access.	
pkazi_f_20131001_726.jpg

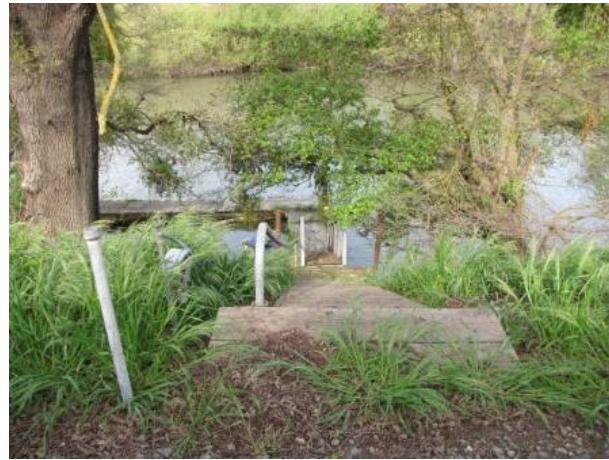
Levee Mile Report Line	9
Start Levee Mile	0.36
End Levee Mile	0.36
Location	Water Side
Category	Earthen Levee
Item	Encroachments
View of steps, a dock, and associated utilities on the waterward slope.	
pkazi_f_20131001_629.jpg

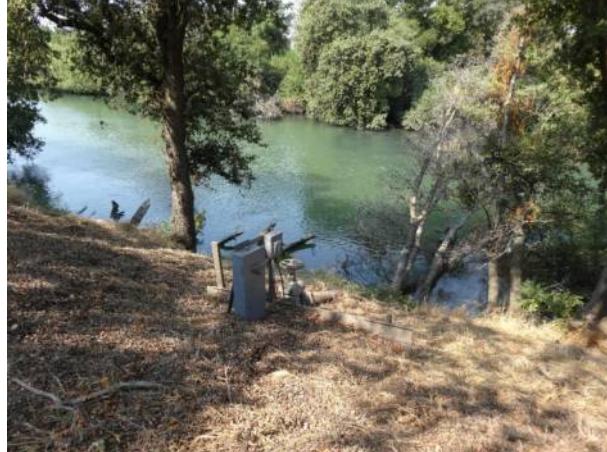
Levee Mile Report Line	12
Start Levee Mile	0.41
End Levee Mile	0.41
Location	Water Side
Category	Supplemental
Item	DWR UCIP Field Study
WS view: pipe and pump on levee slope.	
UCIP_11091.jpg

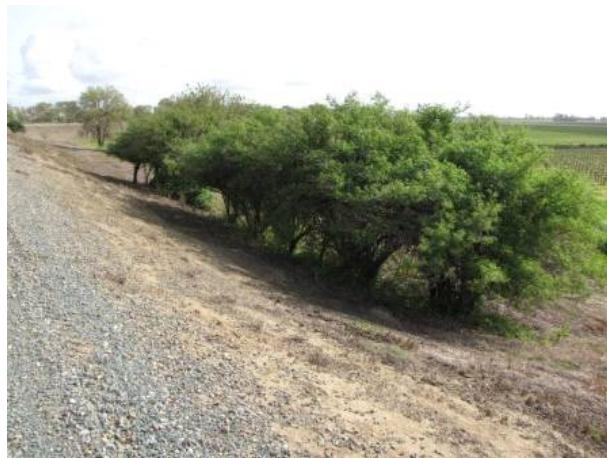
Levee Mile Report Line	15
Start Levee Mile	0.92
End Levee Mile	0.95
Location	Land Side
Category	Earthen Levee
Item	Vegetation
View of elderberries on the landward slope blocking visibility and access.	
pkazi_f_20131001_631.jpg

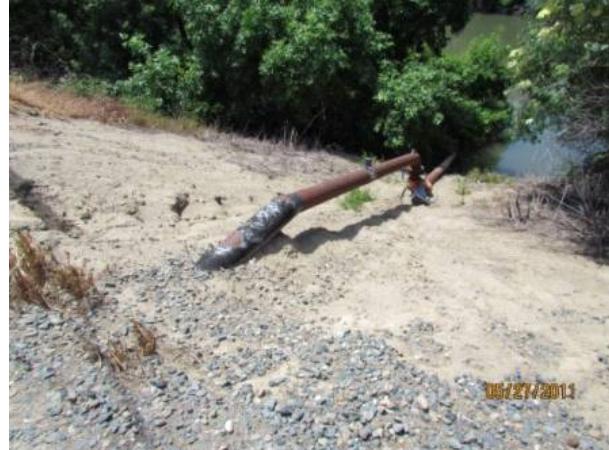
Levee Mile Report Line	19
Start Levee Mile	1.82
End Levee Mile	1.82
Location	Water Side
Category	Earthen Levee
Item	Erosion / Bank Caving
Erosion was found on the waterside slope of the levee near the vicinity of the pipe. The picture was taken from the crown looking downstream.	
pkazi_f_20131001_669.jpg

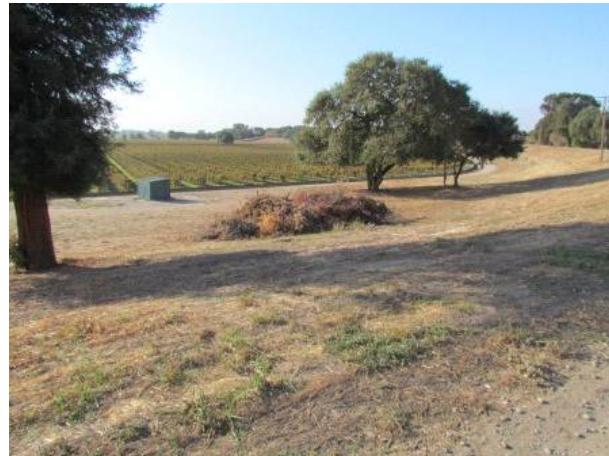
Levee Mile Report Line	20
Start Levee Mile	1.97
End Levee Mile	1.97
Location	Land Side
Category	Earthen Levee
Item	Encroachments
Prunings were found on the landside toe of the levee looking downstream.	
pkazi_f_20131029_018.JPG

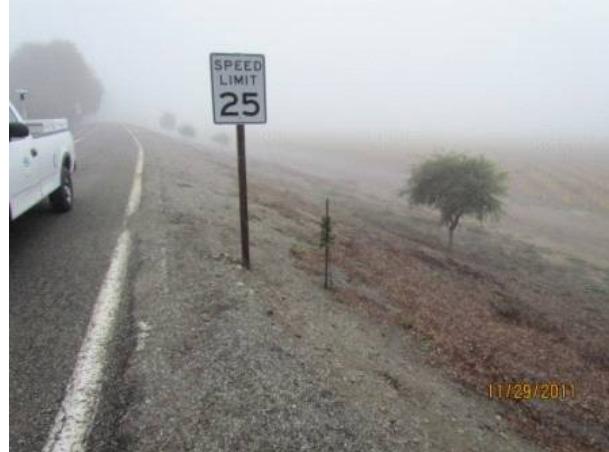
Levee Mile Report Line	21
Start Levee Mile	2.34
End Levee Mile	2.34
Location	Land Side
Category	Earthen Levee
Item	Encroachments
New tree has been planted on the landside slope of the levee looking upstream.	
pkazi_f_20131001_702.jpg

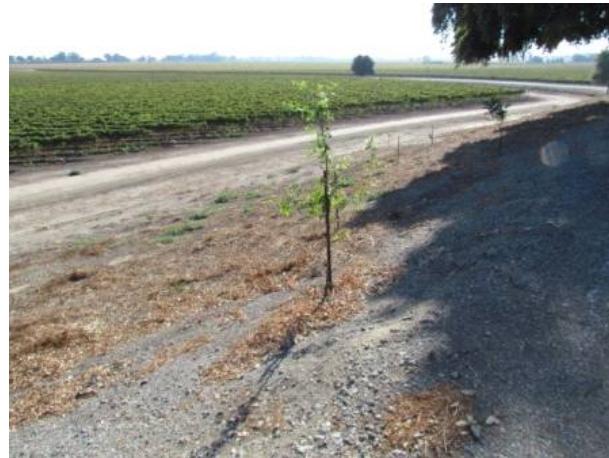
Levee Mile Report Line	21
Start Levee Mile	2.34
End Levee Mile	2.34
Location	Land Side
Category	Earthen Levee
Item	Encroachments
New tree was found on the landside shoulder of the levee looking downstream. This picture was taken during fall 2012 inspection.	
pkazi_f_20131001_704.jpg

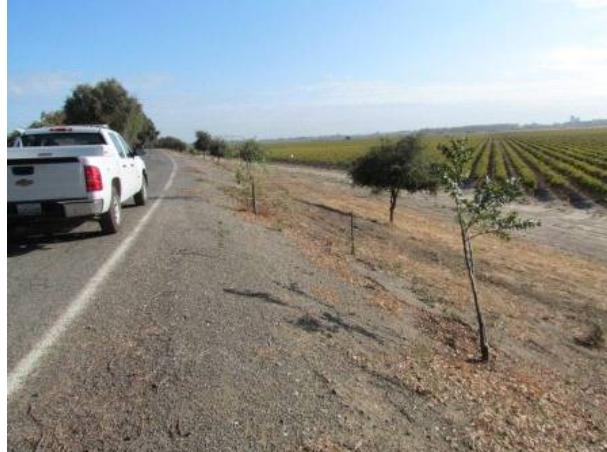
Levee Mile Report Line	21
Start Levee Mile	2.34
End Levee Mile	2.34
Location	Land Side
Category	Earthen Levee
Item	Encroachments
Several newly planted tree were found on the landside slope of the levee looking upstream during the fall 2013 inspection.	pkazi_f_20131029_019.JPG

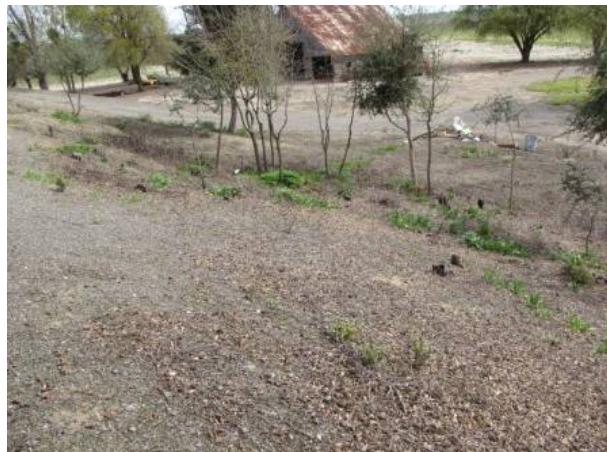
Levee Mile Report Line	22
Start Levee Mile	2.60
End Levee Mile	2.60
Location	Land Side
Category	Earthen Levee
Item	Trim / Thin Trees
View of tree stumps on the landward slope.	pkazi_f_20131001_634.jpg

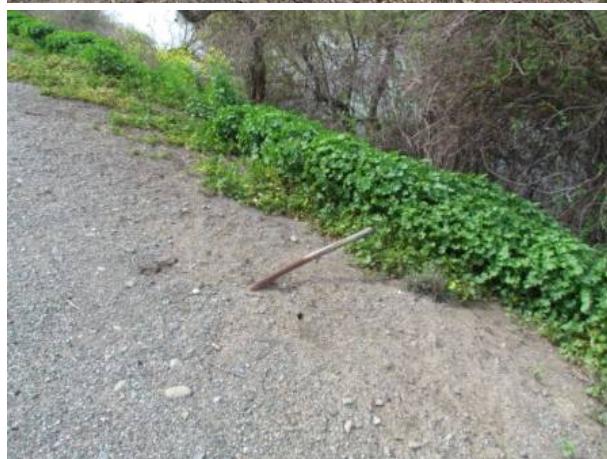
Levee Mile Report Line	23
Start Levee Mile	2.71
End Levee Mile	2.71
Location	Water Side
Category	Earthen Levee
Item	Encroachments
A pipe was found on the waterside shoulder of the levee looking downstream during spring 2013 inspection.	pkazi_f_20131001_654.JPG

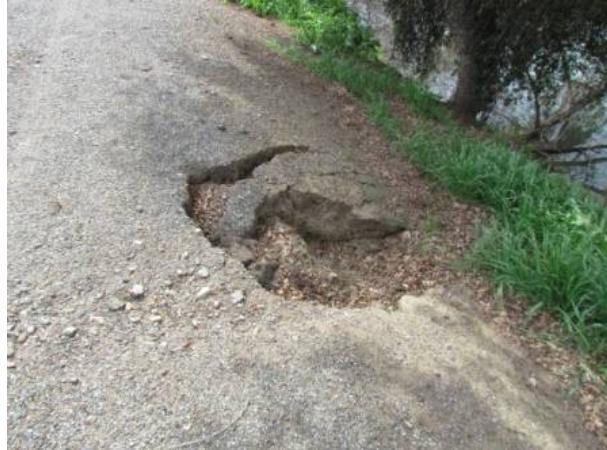
Levee Mile Report Line	24
Start Levee Mile	2.86
End Levee Mile	2.86
Location	Water Side
Category	Earthen Levee
Item	Erosion / Bank Caving
Erosion was found on the waterside slope of the levee looking downstream during spring 2013 inspection.	
pkazi_f_20131001_655.JPG

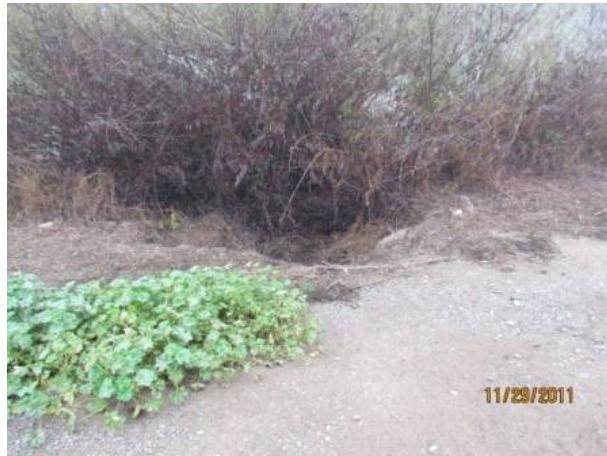
Levee Mile Report Line	26
Start Levee Mile	2.93
End Levee Mile	2.93
Location	Water Side
Category	Earthen Levee
Item	Slope Stability
Slope instability was found on the waterside of the levee. The picture was taken from the crown looking towards the toe of the levee.	
pkazi_f_20131001_699.jpg

DWR ID: DWR_RD0150_03_s_2012_17	
26	2.93	2.93	Earthen Levee	Slope Stability	WS M Ma		S1 : Repair slope instability.	38.361375 °	38.361375 °	76 -121.562134 ° -121.562134 ° Y	
										DWR ID: DWR_RD0150_03_s_2012_76	
27	2.93	2.93	Earthen Levee	Crown Surface / Depressions / Rutting	CR C Ma		C3 : Add appropriate gravel or road base. Grade and compact.	38.361375 °	38.361375 °	75 -121.562135 ° -121.562135 °	
										DWR ID: DWR_RD0150_03_s_2012_75	
28	3.18	3.18	Earthen Levee	Trim / Thin Trees	WS C Ma		T2 : Thin trees to allow visibility of the ground and room to flood fight.	38.363800 °	38.363800 °	19 -121.560128 ° -121.560128 °	
										DWR ID: DWR_RD0150_03_s_2012_19	
29	3.21	3.21	Earthen Levee	Trim / Thin Trees	WS N Ma		T5 : Tree stumps.	38.363658 °	38.363658 °	20 -121.559583 ° -121.559583 ° Y	
										DWR ID: DWR_RD0150_03_s_2012_20
